Site Accessibility Evaluation

Mansker's Visitors Center

**705 Caldwell Dr
Goodlettsville, TN 37072**

ADA Only

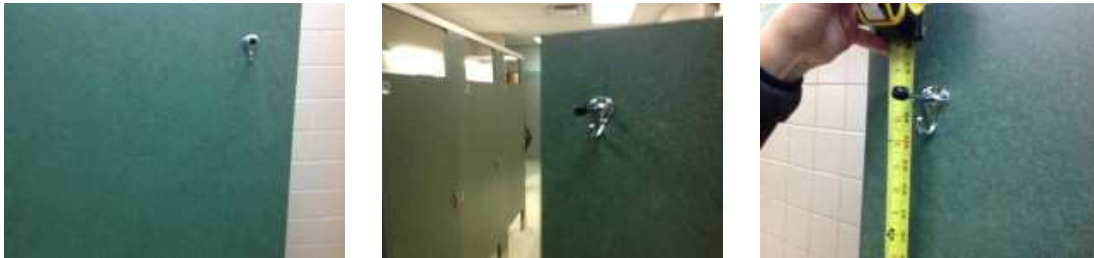
Finding #29, Additional Finding Photos

29	Restrooms	36.3235743504/ -86.6895420377	The hook is positioned too high for either a side or front approach. Where a clear floor or ground space allows a parallel approach to an element and the side reach is unobstructed, the high side reach shall be 48 inches maximum and the low side reach shall be 15 inches minimum above the finish floor or ground. Where a forward reach is unobstructed, the high forward reach shall be 48 inches maximum and the low forward reach shall be 15 inches minimum above the finish floor or ground.	hooks in M/W restrooms mounted at 65"	Remount operable parts to be in reach range of 15" min to 48" max For deficit, leave as is, employee work area pursuant to 2010 Standards 106.5 Defined Terms, until an employee with a disability works here	2015 ABAAS Section: 308.1 2010 ADAS Section: 308.1	Phase 1 (1)
