Site Accessibility Evaluation

Peay Park

200 Memorial Dr
Goodlettsville, TN 37072

Inspection Date: 12/18/2017
Inspector: Shelley Zuniga

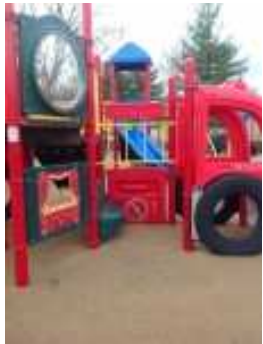
Finding #14, Additional Finding Photos

Finding Number	Area Description	Lat/Long	Finding	As Built	Recommendation	Citation	Phase	Photo	Figure
14	Play Area	36.3212046043/ -86.7151777446	Element meets all standards and requirements	13/13 on 5-12 structure	None	2010 ADAS Section: 240.2.2, 1008.4	Phase 2 (2)
